NCR ATM SECURITY UPDATE

DATE: June 30, 2017

INCIDENT NO: 2017-08

Eavesdropping Skimming Attacks on SelfServ™ ATMs in the USA

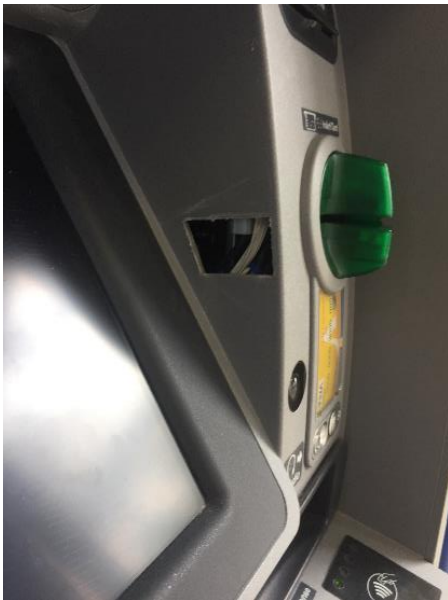
The ATM model targeted is the 6634, a Through-The-Wall (TTW) multifunction ATM. The attacker cuts a rectangular hole the in the side panel in between the ATM monitor and the card reader. This hole is then used to place an Eavesdropping Skimmer beneath the card reader, to connect directly to the card reader magnetic read head. The hole in the ATM is then disguised by fixing a color matched panel over the entire side panel of the ATM. See pictures below.

Hole in ATM Side Panel

For motorized card readers, NCR has a solution in addition to SPS which will stop eavesdropping attacks in the form of the Anti-Eavesdropping Kit. This is available as both a factory fitted feature Product ID 66XX-F708, or as an upgrade kit Product ID 6634-K708-V003.

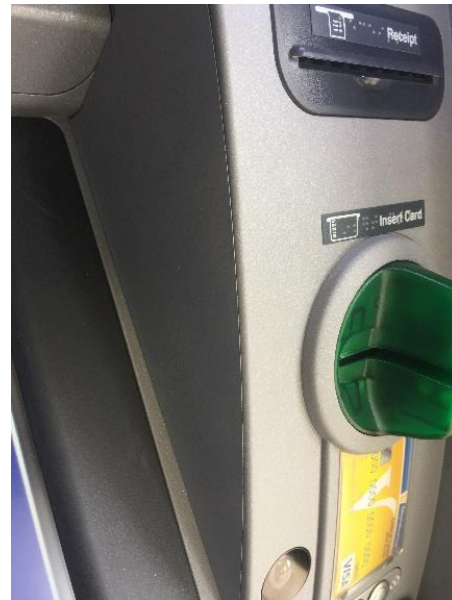
Hole disguised with overlay

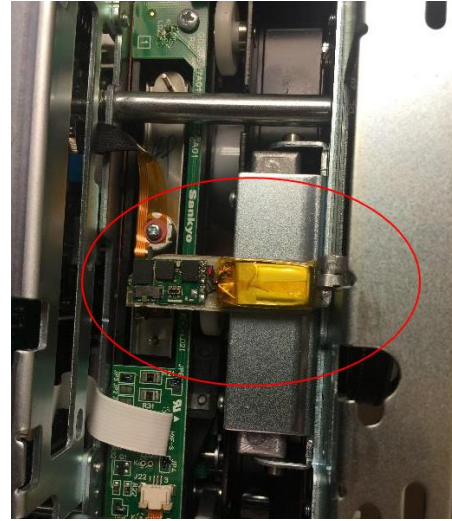
Skimmer attached below card reader -
viewed from below
